Incident report

D 1/2000 Y,
shortened version

Bus Fires in Finland during 2000

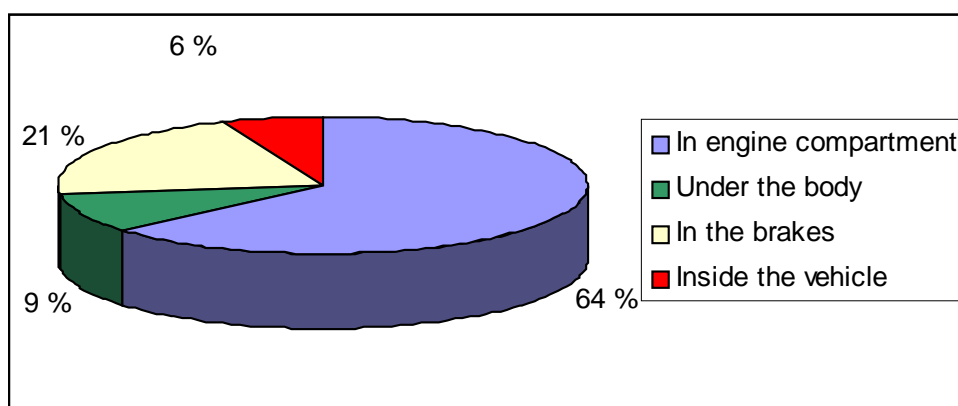
Diagram 7. Origins of the fire.

A total of 31 fires started outside the passenger compartment, 21 of which started in the engine compartment, 7 in the brakes and 3 from under the body.

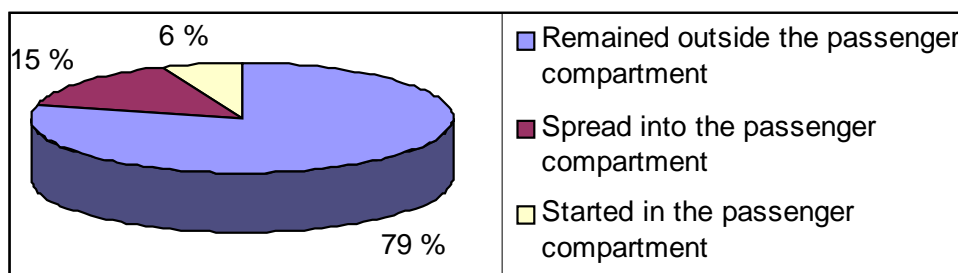
Diagram 8. Spreading of the fire.

Five of the fires that started outside the passenger compartment spread to the passenger compartment. Two of the vehicles were destroyed beyond repair, two were badly damaged and one was slightly damaged. Furthermore, one of the vehicles in which the fire started in the passenger compartment was destroyed.

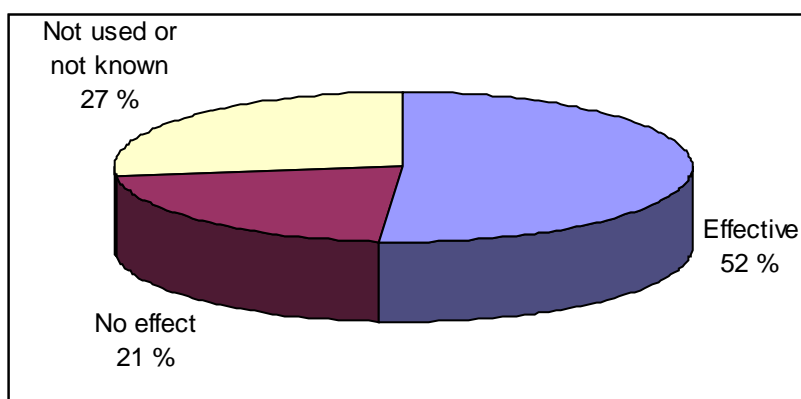
Diagram 9. First-hand extinguishing.

First-hand extinguishing succeeded in 17 incidents. The most common reason for failure was the premature discharge of the extinguisher's contents, i.e. the extinguisher's capacity was too small.

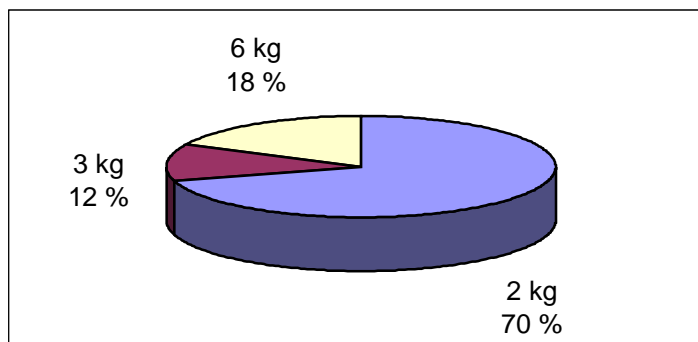
Diagram 10. The size of the fire extinguisher installed in vehicles, by incident.

In buses a dry powder extinguisher with at least a 2 kg capacity is required; this has proved to be too small in many extinguishing situations, i.e. the extinguisher contents were exhausted before the fire was put out, or the fire re-ignited again when the extinguisher had discharged its contents. Only in four incidents was a 6 kg extinguisher available.

In those incidents about which the size of the fire extinguisher is known there were 15 instances of a 2 or 3 kg dry powder extinguisher, and 4 instances of a 6 kg extinguisher. A 2 or 3 kg extinguisher was often found to be inadequate. It is thus justifiable to propose that every vehicle should be equipped with at least a 6 kg fire extinguisher.

Investigators recommend that the Ministry of Transport and Communications should prescribe a fire extinguisher of at least 6 kg in buses instead of the current 2 kg hand extinguisher. [D1/00Y/S2]

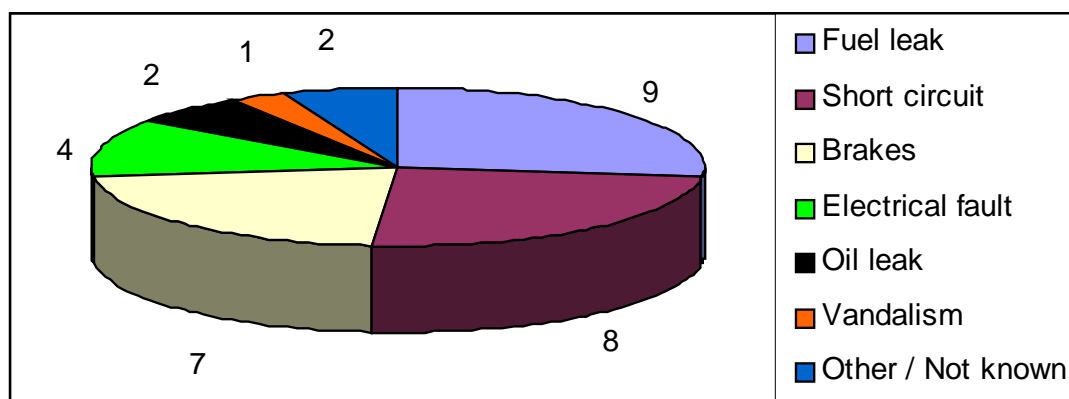
Diagram 12. Causes of the fires.

The causes of the fires can be roughly divided into four categories: fuel leaks (28%), short circuits (24%), brake fires (21%) and other causes (27%).
